**Flood Control Project Maintenance
Levee Inspections**

Maintenance Issue Types Only, Levee Inspection Report By Mile - Spring 2015

Reclamation District No. 0817 Carlin

Waterway	Bank	Unit Miles	Inspection Start/End	Inspector
Unit No. 01 South Dry Creek	Left	3.81	05/27/2015 05/27/2015	Michael Pitta

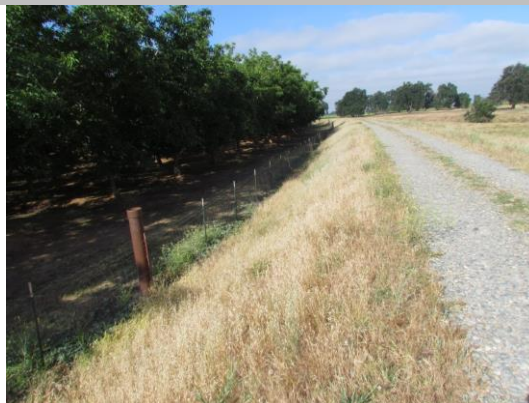
Photo 1 of 1 : SP_2015_RD0817_12_2_20150529_00005.jpg

LM Start	0.00	Rating **	M	Issue No.	2
LM End	3.80	Issue Type +	Ma	Location *	LS
Category	Earthen Levee			GPS Latitude/Longitude	
				Start	End
Item	Vegetation			38.984611 °	39.019712 °
				-121.506089 °	-121.454278 °
DWR ID	DWR_RD0817_01_s_2015_2				
Action/Comments					
Control annual grass and weeds on the levee slopes and easements.

View of the vegetation on the landside of the levee facing downstream.

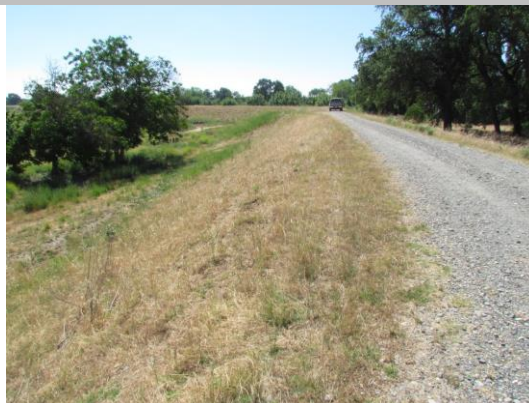
Photo 1 of 1 : SP_2015_RD0817_13_3_20150529_00007.jpg

LM Start	0.00	Rating **	M	Issue No.	3
LM End	1.38	Issue Type +	Ma	Location *	LS
Category	Earthen Levee			GPS Latitude/Longitude	
				Start	End
Item	Vegetation			38.984608 °	38.986357 °
				-121.506089 °	-121.481006 °
DWR ID	DWR_RD0817_02_s _ 2015_3				
Action/Comments					
Control annual grass and weeds on the levee slopes and easements.

View of the vegetation on the landside of the levee facing upstream.

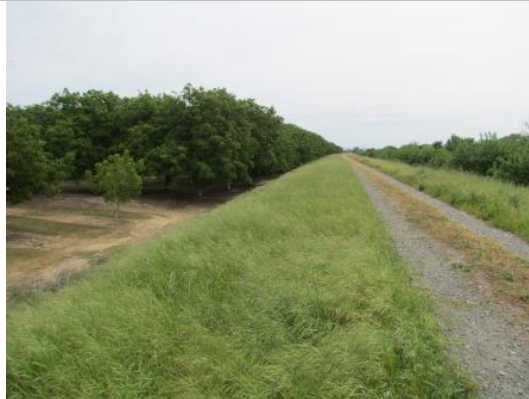
Photo 1 of 1 : SP_2015_RD0817_13_5_20150401_00001.jpg

LM Start	0.01	Rating **	A/W	Issue No.	5
LM End	1.19	Issue Type +	Ma	Location *	LS
Category	Earthen Levee			GPS Latitude/Longitude	
				Start	End
Item	Vegetation			38.984502 °	38.985971 °
				-121.505957 °	-121.484564 °
DWR ID	DWR_RD0817_02_f_2012_5				
Action/Comments					
Remove the wild growth other than native grasses from the levee slopes.

This photo was taken from the levee crown facing east looking down the landward levee slope at vegetation requiring maintenance. Spring 2014.

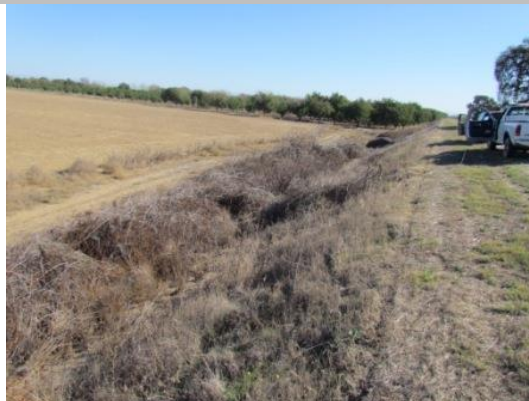
Photo 1 of 1 : SP_2015_RD0817_13_9_20150401_00003.jpg

LM Start	0.27	Rating **	U	Issue No.	9
LM End	0.27	Issue Type +	Ma	Location *	LS
Category	Earthen Levee			GPS Latitude/Longitude	
				Start	End
Item	Vegetation			38.984308 °	38.984308 °
				-121.501561 °	-121.501561 °
DWR ID	DWR_RD0817_02_f_2013_9				
Action/Comments					
Remove the wild growth other than native grasses from the levee slopes. Inspector Comments: Berry bushes have been sprayed but still need to be removed.

This photo was taken from the crown of the levee facing east looking at the blackberry bushes on the landward slope of the levee. They have been sprayed but still need to be removed.

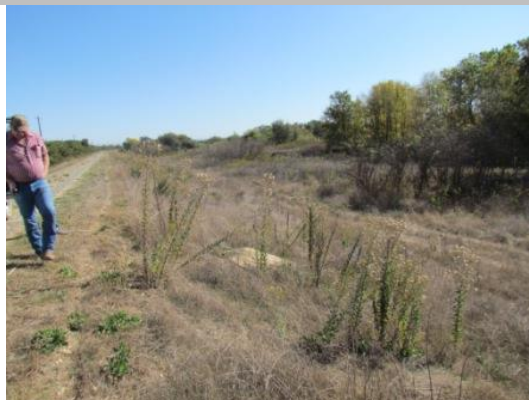
Photo 1 of 1 : SP_2015_RD0817_13_14_20150401_00005.jpg

LM Start	2.17	Rating **	U	Issue No.	14
LM End	2.17	Issue Type +	Ma	Location *	WS
Category	Earthen Levee			GPS Latitude/Longitude	
				Start	End
Item	Animal Control			38.989727 °	38.989727 °
				-121.467162 °	-121.467162 °
DWR ID	DWR_RD0817_02_f_2013_14				
Action/Comments					
Exterminate rodents and backfill and compact or grout burrows. Inspector Comments: Medium sized animal burrow in the the waterward side of the levee slope.

This photo was taken from the crown of the levee facing east looking at a medium sized animal burrow in the the waterward side of the levee slope.

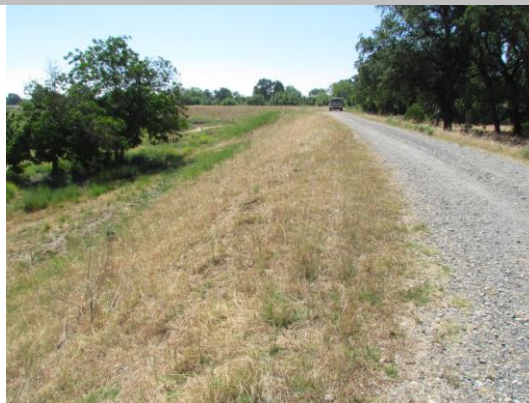
Photo 1 of 1 : SP_2015_RD0817_14_2_20150529_00010.jpg

LM Start	0.25	Rating **	M	Issue No.	2
LM End	1.57	Issue Type +	Ma	Location *	LS
Category	Earthen Levee			GPS Latitude/Longitude	
				Start	End
Item	Vegetation			38.987584 °	39.000565 °
				-121.506617 °	-121.490638 °
DWR ID	DWR_RD0817_03_s _ 2015_2				
Action/Comments					
Control annual grass and weeds on the levee slopes and easements.

View of the vegetation on the landside of the levee facing upstream.

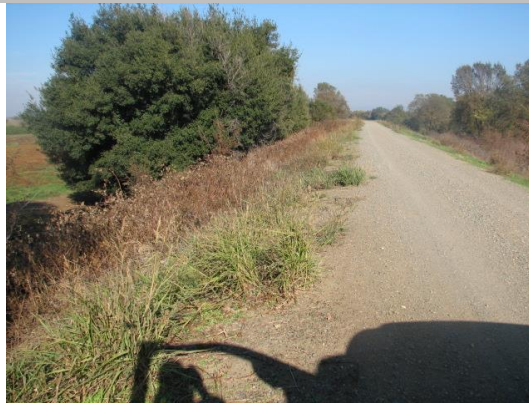
Photo 1 of 1 : SP_2015_RD0817_14_8_20150401_00001.jpg

LM Start	0.55	Rating **	U	Issue No.	8
LM End	0.81	Issue Type +	Ma	Location *	LS
Category	Earthen Levee			GPS Latitude/Longitude	
				Start	End
Item	Vegetation			38.989961 °	38.992220 °
				-121.502009 °	-121.498198 °
DWR ID	DWR_RD0784_06_f _ 2012_8				
Action/Comments					
Remove the wild growth other than native grasses from the levee slopes.					
Inspector Comments: Dense berry bushes along lower slope.

Levee mile 0.54, the landside slope.

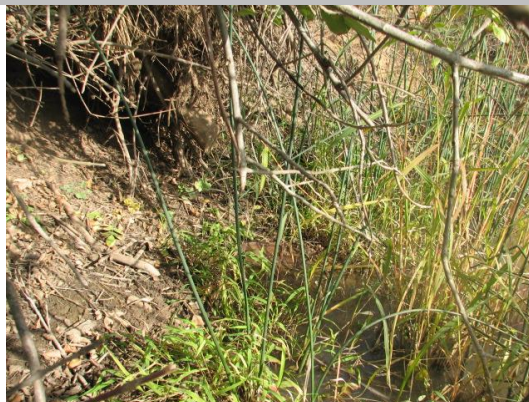
Photo 1 of 3 : SP_2015_RD0817_14_11_20150401_00003.jpg

LM Start	0.69	Rating **	U	Issue No.	11
LM End	0.69	Issue Type +	Ma	Location *	WS
Category	Interior Drainage & Piping Systems			GPS Latitude/Longitude	
				Start	End
Item	Culverts: Breaks / Holes / Cracks			38.991084 °	38.991084 °
				-121.499871 °	-121.499871 °
DWR ID	DWR_RD0784_06_f_2012_11				
Action/Comments

Levee mile 0.68, this is located near the low flow channel, the flap gate is lying on the ground, the end of the pipe was not located.

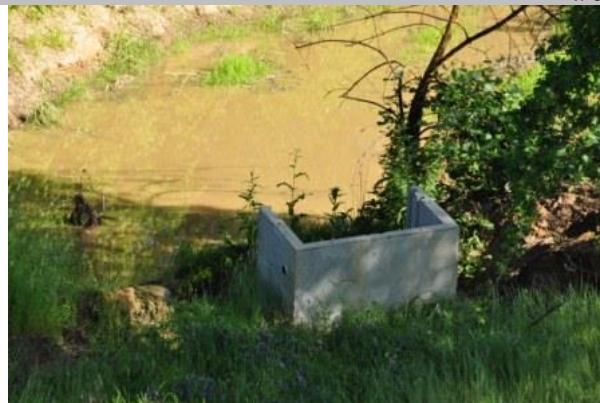
Photo 2 of 3 : SP_2015_RD0817_14_11_20150401_00004.jpg

LM Start	0.69	Rating **	U	Issue No.	11 (cont)
LM End	0.69	Issue Type +	Ma	Location *	WS
Category	Interior Drainage & Piping Systems			GPS Latitude/Longitude	
				Start	End
Item	Culverts: Breaks / Holes / Cracks			38.991084 °	38.991084 °
				-121.499871 °	-121.499871 °
DWR ID	DWR_RD0784_06_f_2012_11				
Action/Comments

L/S Intake at LM 0.68

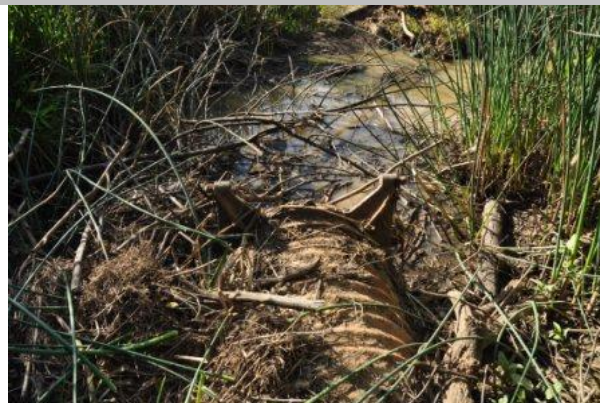
Photo 3 of 3 : SP_2015_RD0817_14_11_20150401_00005.jpg

CMP is rusting and has numerous holes but flap gate is in place.
4/25/13 - Burnett

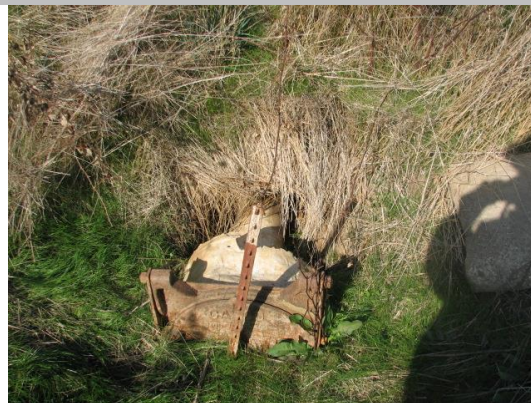
Photo 1 of 1 : SP_2015_RD0817_14_10_20150401_00002.jpg

LM Start	1.18	Rating **	U	Issue No.	10
LM End	1.18	Issue Type +	Ma	Location *	WS
Category	Interior Drainage & Piping Systems			GPS Latitude/Longitude	
				Start	End
Item	Culverts: Breaks / Holes / Cracks			38.995856 °	38.995856 °
				-121.493110 °	-121.493110 °
DWR ID	DWR_RD0784_06_f_2012_10				
Action/Comments

Levee mile 1.17 near the low flow channel, it appears a smaller pipe has been sleeved into the larger pipe, the flap gate does not make contact with the smaller pipe.

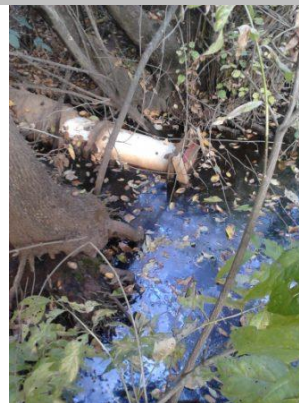
Photo 1 of 1 : SP_2015_RD0817_14_16_20150401_00008.jpg

LM Start	1.26	Rating **	M	Issue No.	16
LM End	1.33	Issue Type +	Ma	Location *	WS
Category	Interior Drainage & Piping Systems			GPS Latitude/Longitude	
				Start	End
Item	Culverts: Inlets / Outlets				°
					°
DWR ID	DWR_RD0784_06_f_2012_16				
Action/Comments

Levee mile 1.33 waterside of the levee, this pipe appears to be sleeved into a larger pipe, access to both ends is limited.

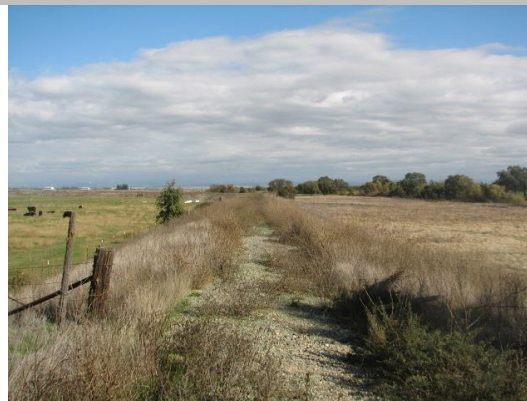
Photo 1 of 1 : SP_2015_RD0817_14_14_20150401_00006.jpg

LM Start	1.28	Rating **	U	Issue No.	14
LM End	1.50	Issue Type +	Ma	Location *	CR
Category	Earthen Levee			GPS Latitude/Longitude	
				Start	End
Item	Vegetation			38.997019 °	38.999719 °
				-121.491802 °	-121.490147 °
DWR ID	DWR_RD0784_06_f_2012_14				
Action/Comments					
Remove the wild growth other than native grasses from the levee slopes.

Levee mile 1.27 looking upstream, typical of the levee in this section.
